PHOTOGRAPHIC INTELLIGENCE REPORT

STATUS OF NORTH VIETNAMESE RAILROADS

Report No. 15
CIA/PIR 75056

DATE November 1966

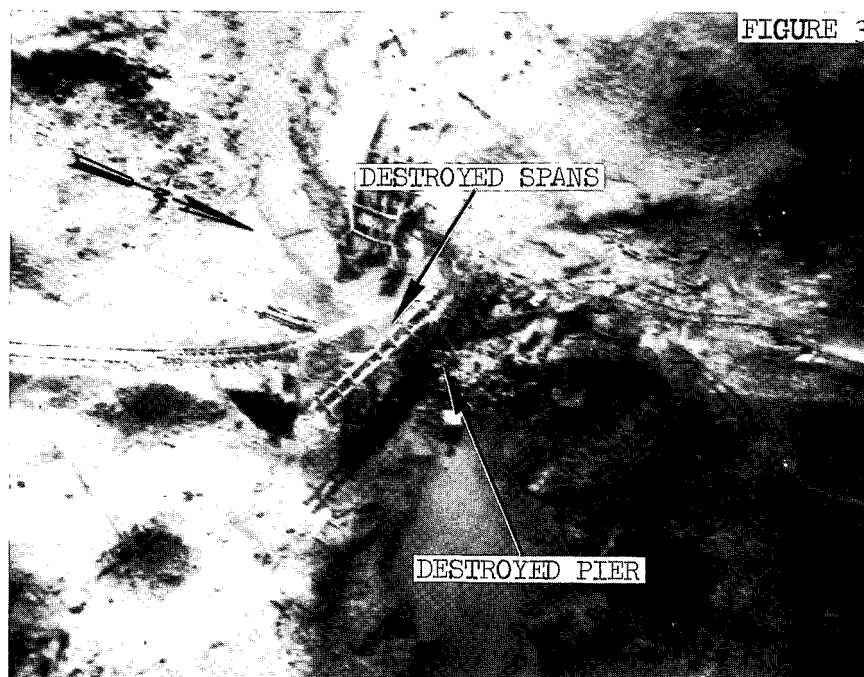
NAME : Lang Quach Ngoai RR. Bridge N

Photography of [] reveals that all spans and 1 pier of the 3-span, deck-beam Lang Quach Ngoai RR. Bridge N have been destroyed. One wooden pier and the concrete abutments remain intact.

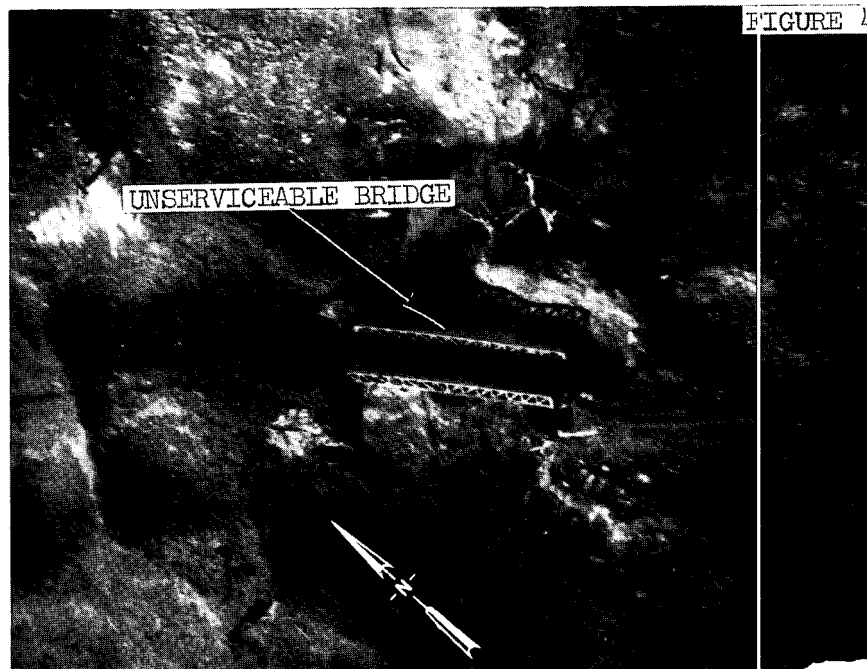
NAME : Khe Se RR. Bridge No. 1

The Khe Se Railroad Bridge No. 1 was observed unserviceable on [redacted] (Report No. 14). Photography of [redacted] reveals that the bridge has been restruck and is still unserviceable (Figure 4). The half-through truss span has now been dropped from both abutments. No attempt at bridge reconstruction was noted on the [redacted] photography implying that the bridge was continuously unserviceable for at least 10 days.

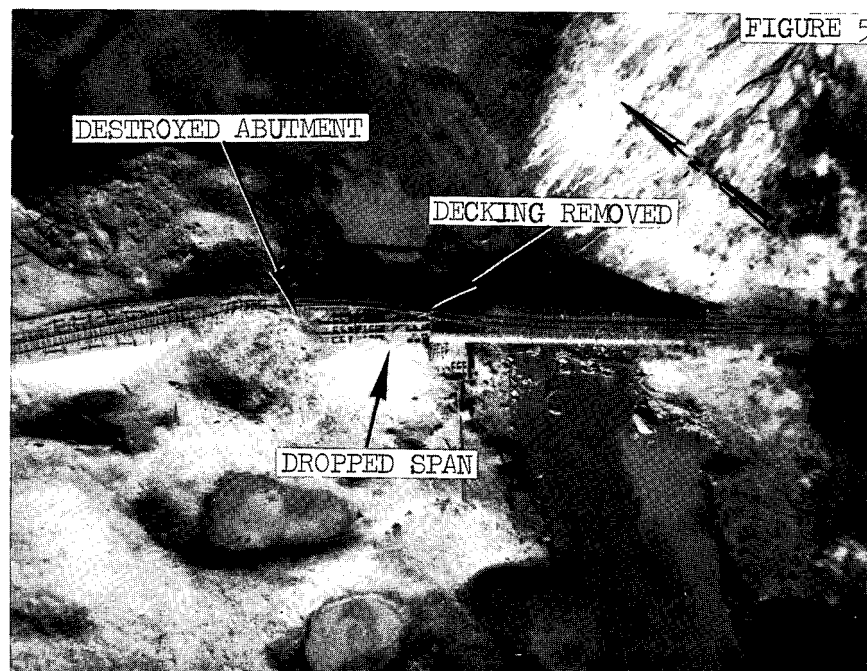
NAME : Lang Khay RR. Bridge

Photography [] reveals that the 3-span, deck-type Lang Khay Railroad Bridge is unserviceable. One abutment has been destroyed, 1 span has been dropped, and the decking has been torn from the dropped span and an adjacent damaged one. This bridge was serviceable [] (Report 14). It could have been used a maximum of 10 days since that time.

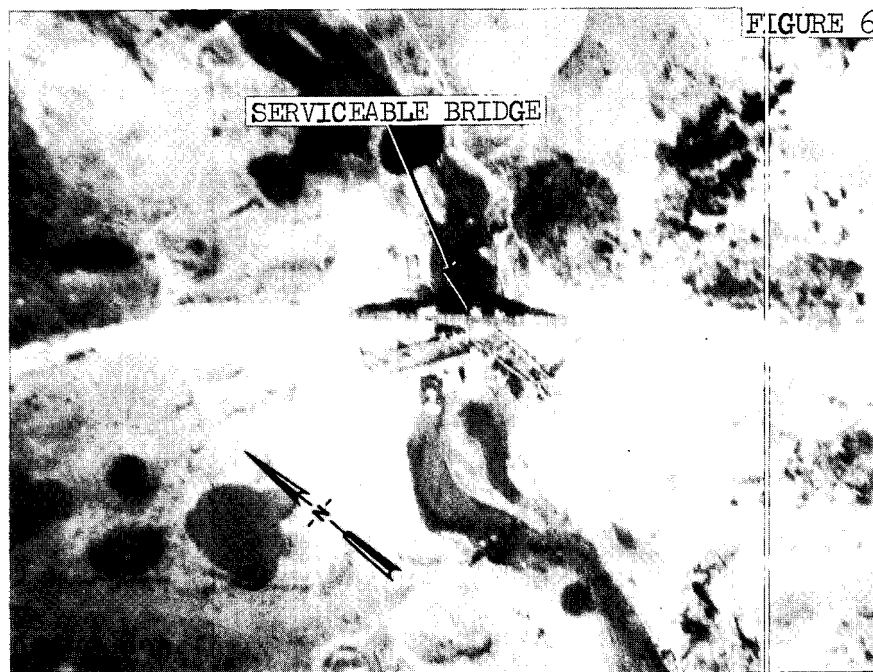
NAME : Lang Bun RR. Bridge

Photography [] reveals that the 8-span, deck-beam Lang Bun Railroad Bridge has been completely repaired and is now serviceable. The bridge was unserviceable when last seen [] (Report 14).

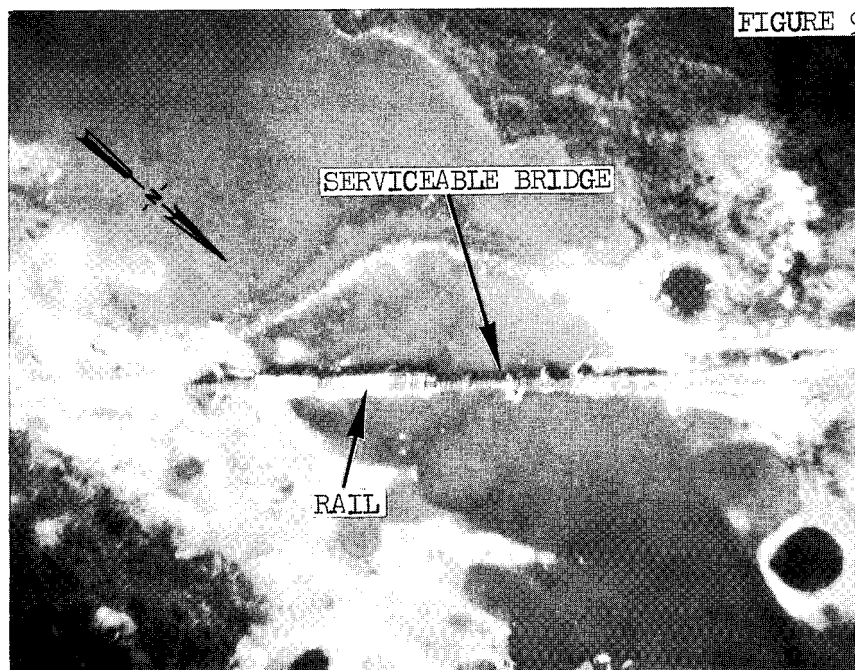
NAME : La Khe Thon Railroad By-Pass Bridge

Photography [] reveals that the former La Khe Thon Highway Bridge has been reconstructed and is now serviceable to rail traffic only.

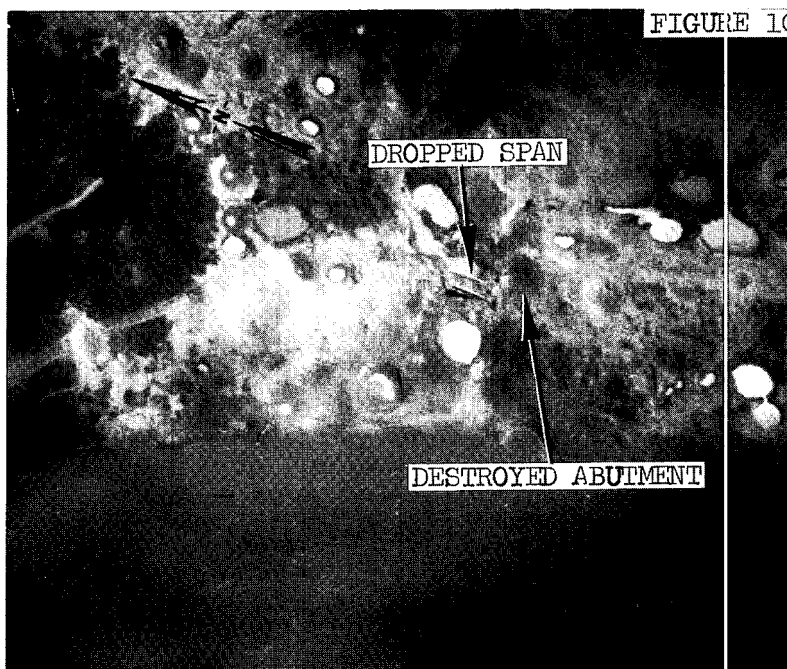
NAME : Hoa Duyet RR. Bridge

Photography [REDACTED] reveals that the unserviceable single-span, deck-type Hoa Duyet Railroad Bridge has incurred further damage. Additional damage consists of 1 abutment destroyed and 1 end of the span dropped.

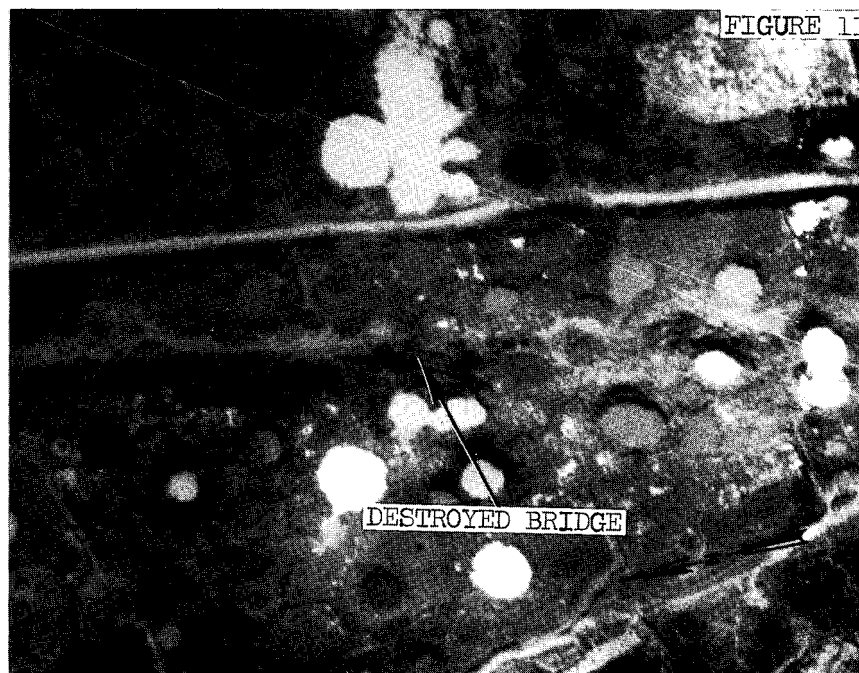
FIGURE 11

Photography [] reveals that single-span, deck-type
Phu Cu Railroad Bridge has been destroyed.

DESTROYED BRIDGE

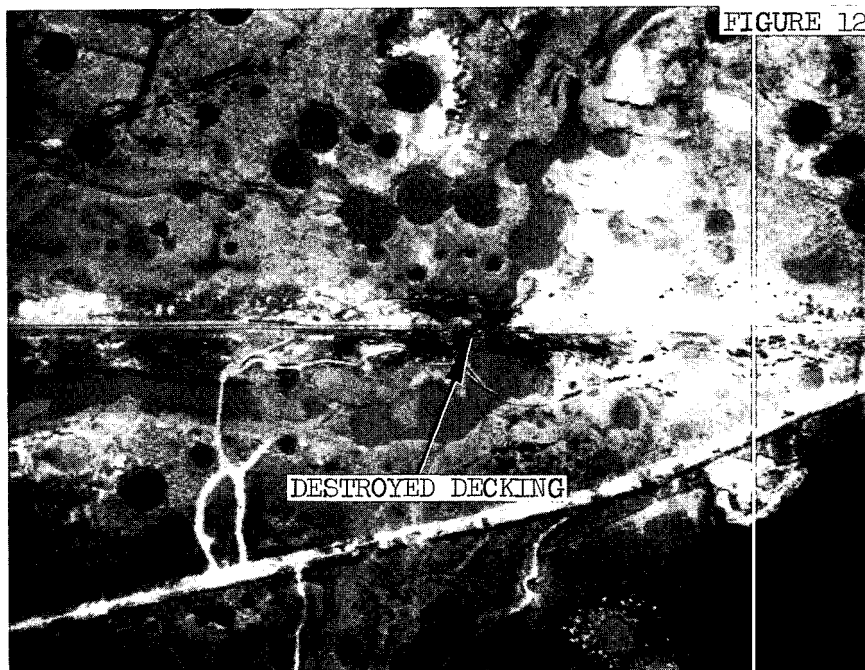
FIGURE 12

Photography [] reveals that the Phu Quat Railroad Bridge is unserviceable. The decking has been destroyed on 2 of the 4 spans of the deck-beam replacement bridge.

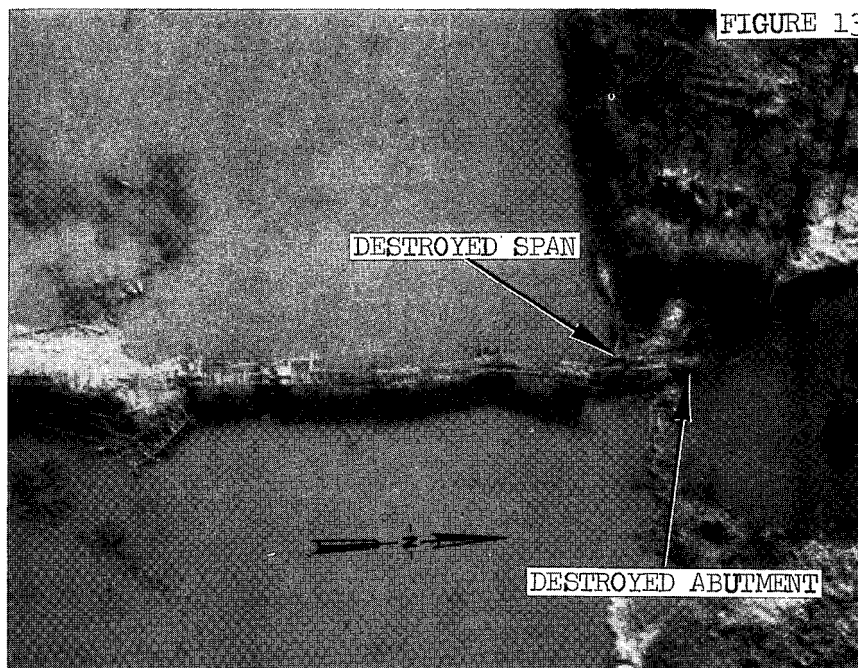
NAME : Trong Quang Tien RR. By-Pass Bridge

Photography [] reveals that the 5-span, deck-beam Trong Quang Tien Railroad By-pass Bridge is unserviceable. One abutment and 1 span have been destroyed, 2 spans are out of alignment, and both approaches have been cut. The main bridge remains serviceable.

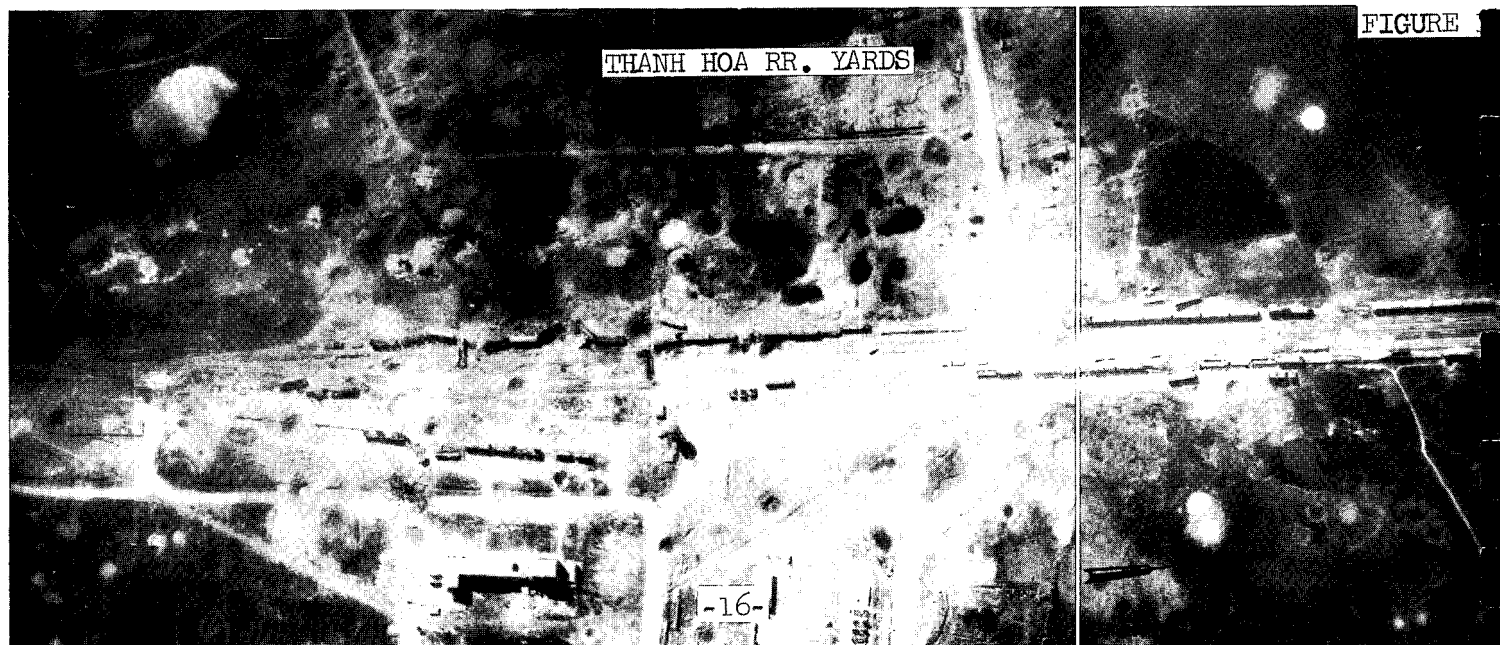
NAME : Thanh Hoa RR. Station and Yards

Photography permits a detailed analysis of bombing damage to the Thanh Hoa RR. Yards. The choke points remain intact, but much of the yard is cratered and blocked with destroyed rolling stock. There is no through line open. An analysis of damage to the rolling stock is as follows (numbers are approximate):

<u>Type of Car</u>	<u>Destroyed</u>	<u>Damaged</u>	<u>Undamaged</u>
Box	16	8	25
Flat	3	-	7
Small Flat	3	6	23
Gondola	4	4	3
Tank	-	1	2
TOTAL	26	19	60

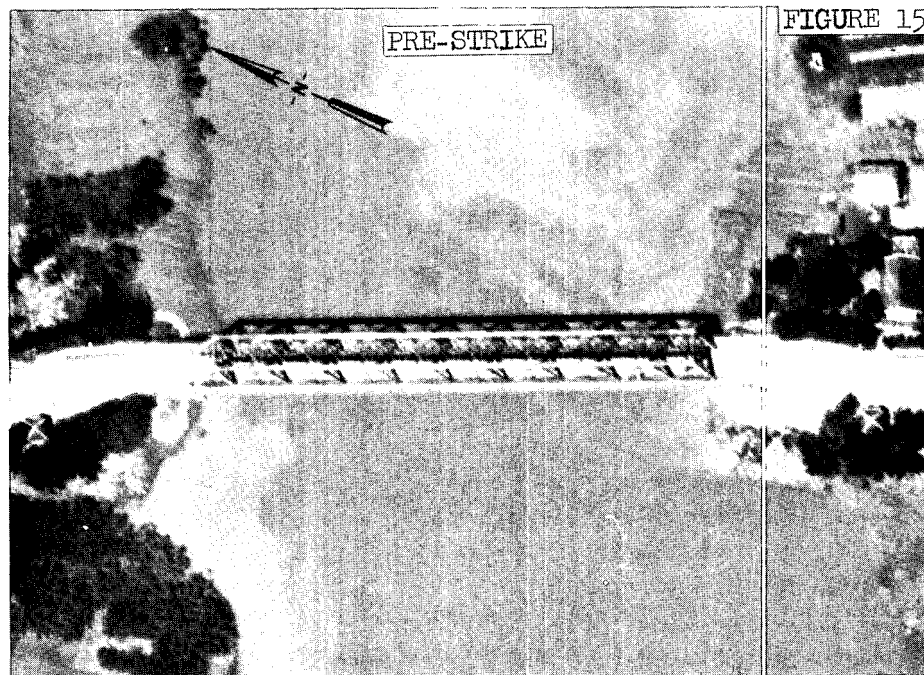
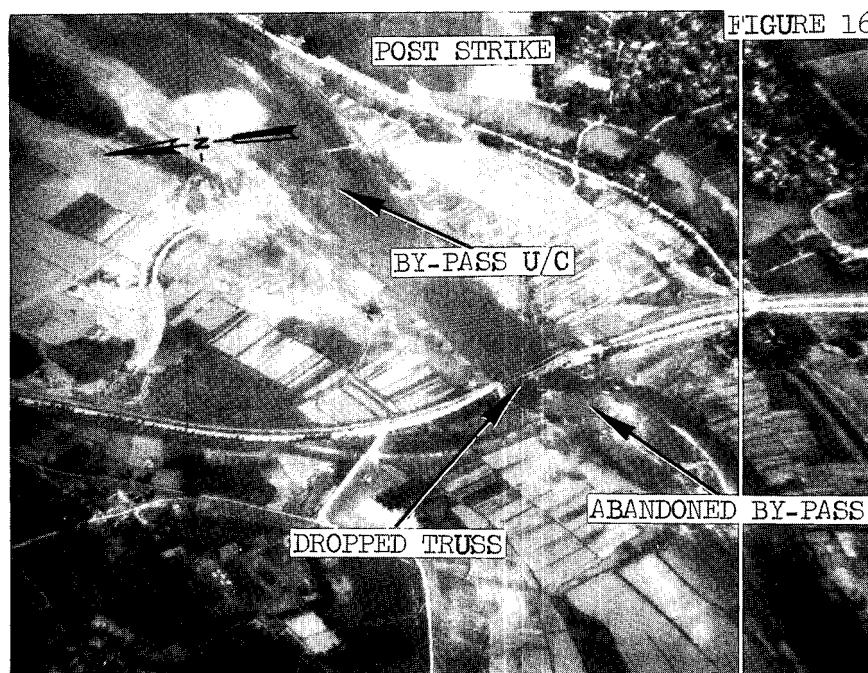
NAME : Phuong Dinh RR. and Hwy. Bridge

The continuous through-truss Phuong Dinh Railroad and Highway Bridge has been heavily damaged (Figure 16). One end of the truss section has been dropped. The bridge was originally a single span structure (Figure 15), but 2 supporting piers have since been constructed-probably due to a weakening of the bridge by previous bombing attacks.

Previously observed by-pass construction adjacent to the unserviceable bridge has now been abandoned; however, a new by-pass is under construction approximately 0.2 nm E of the bridge at UTM WG 845951 (Figure 16).

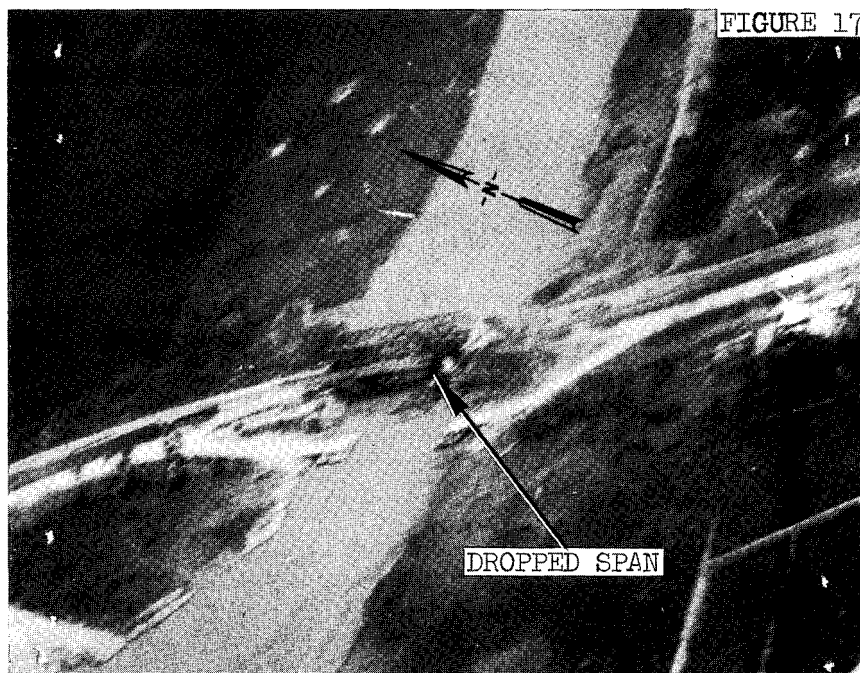
FIGURE 17

Photography [] reveals that 1 end of the deck-type Ha Thon Railroad Bridge By-pass No. 1 has been dropped. The original through-truss Ha Thon Railroad Bridge [] remains unserviceable.

DROPPED SPAN

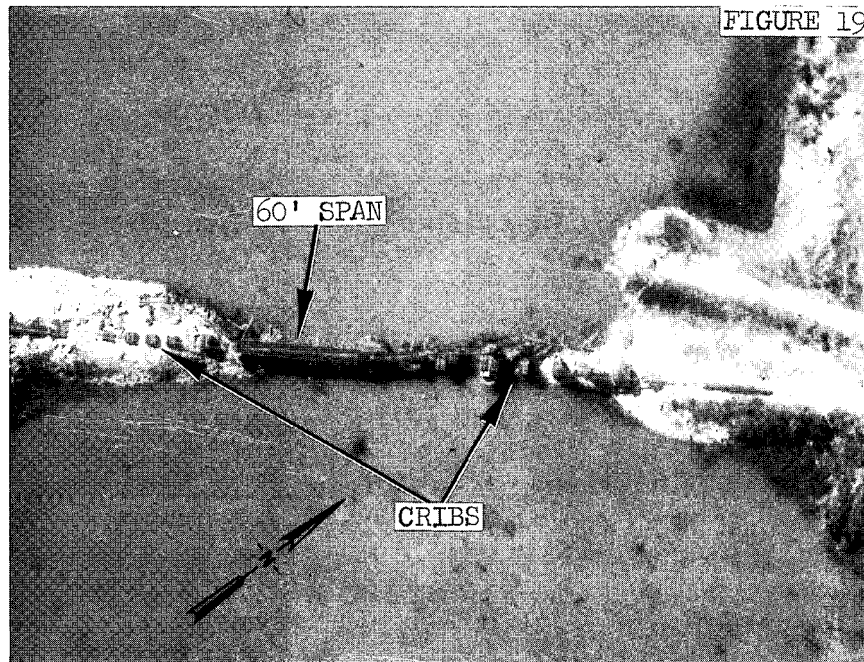
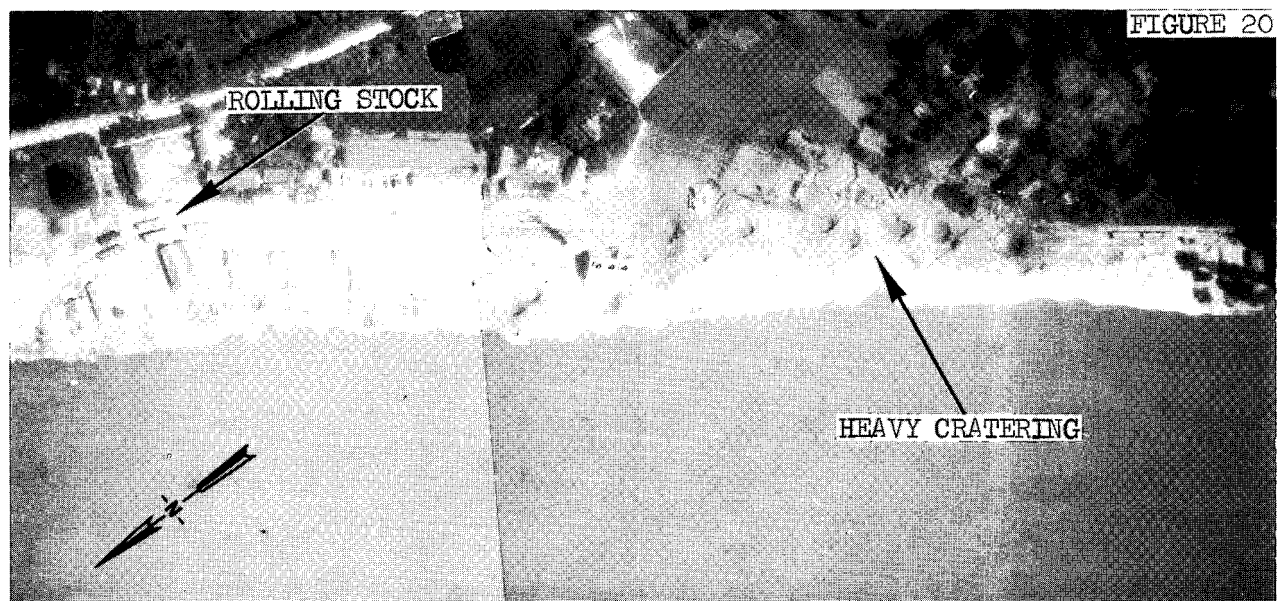
Photography reveals that the Phu Ly Railroad Bridge has been heavily damaged and is unserviceable (Figure 18). Better quality photography reveals that the bridge is being reconstructed (Figure 19). The wooden, deck-beam type bridge will apparently consist of the original 60 foot span and 16 temporary spans averaging 15 feet in length. Cribbing is being constructed for the temporary spans.

Approximately 1.7 nm S of the bridge is a probable rail-to-water transshipment point at UTM WH 957692. Photography reveals that the area has been bombed (Figure 20). The 3-track yard has been heavily cratered and is unserviceable. Seven pieces of rolling stock remain undamaged in the yard.
